INDOOR AIR QUALITY ASSESSMENT

Sewage Backup Follow-up Investigation

**Massachusetts Rehabilitation Commission
1 Federal Street, Building 102-1
Springfield, Massachusetts**

Prepared by:
Massachusetts Department of Public Health
Bureau of Environmental Health
Indoor Air Quality Program
January 2018

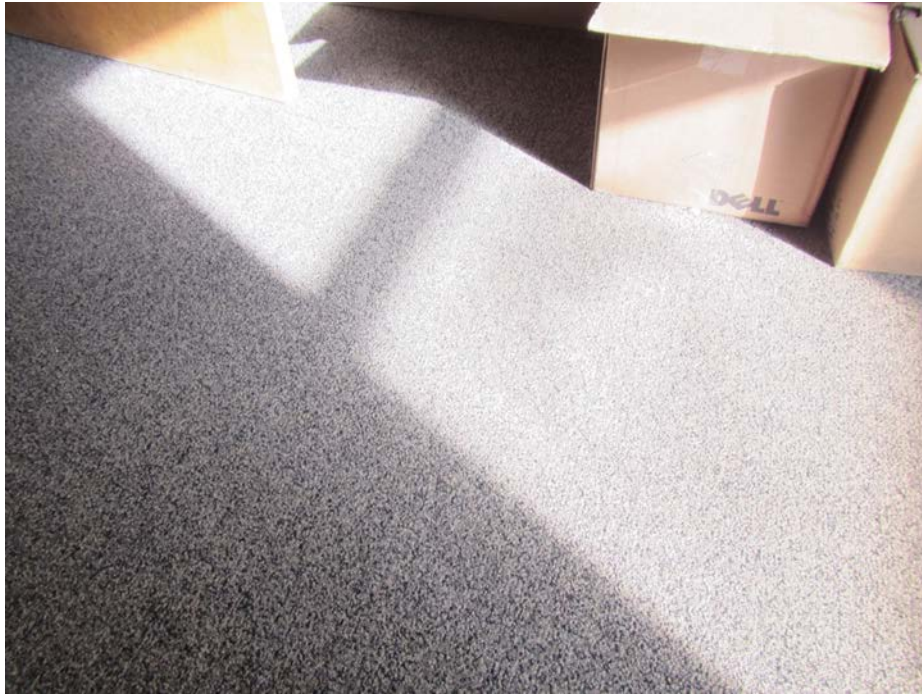
Picture 1

During this follow-up visit, IAQ staff noted that all remaining porous building materials were discarded and replaced. These materials included new gypsum wallboard (GW), new

insulation, and new carpeting (Picture 1). Remaining concrete subfloor and brick walls were sanitized and are not conducive to mold growth.

Newly-installed carpeting

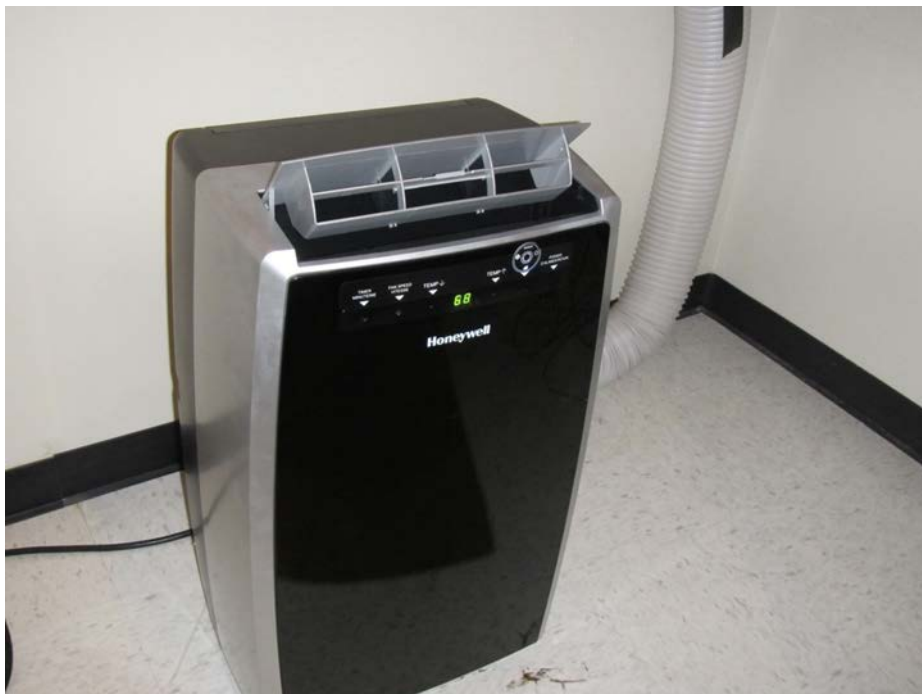
Picture 2

IAQ staff noted a portable air conditioning (AC) unit ducted into a wall cavity/ceiling plenum in the IT server room (Pictures 2 and 3). This type of AC unit does not require a condensation line to remove moisture from the unit. Instead this AC unit has an exhaust air duct with a fan continuously running to evaporate condensate from the unit. These exhaust ducts are typically directed outdoors so that they are not adding warm, humid air to the occupied space. The low humidity during the heating season may reduce the risk of chronic moisture accumulation from this condition. However, during the cooling season, this condition is likely to cause chronic moisture of building materials due to condensation within the wall cavity/ceiling plenum. Chronic moisture on porous materials (e.g., gypsum wallboard) may lead to microbial colonization. The exhaust hose for this unit should be properly ducted outside according to manufacturer recommendations.

Portable AC unit in IT server room

3. Properly vent the portable AC unit in the IT server room to the outside according to manufacturer recommendations.
4. Investigate methods to increase fresh air supply to room #112 and adjoining room.

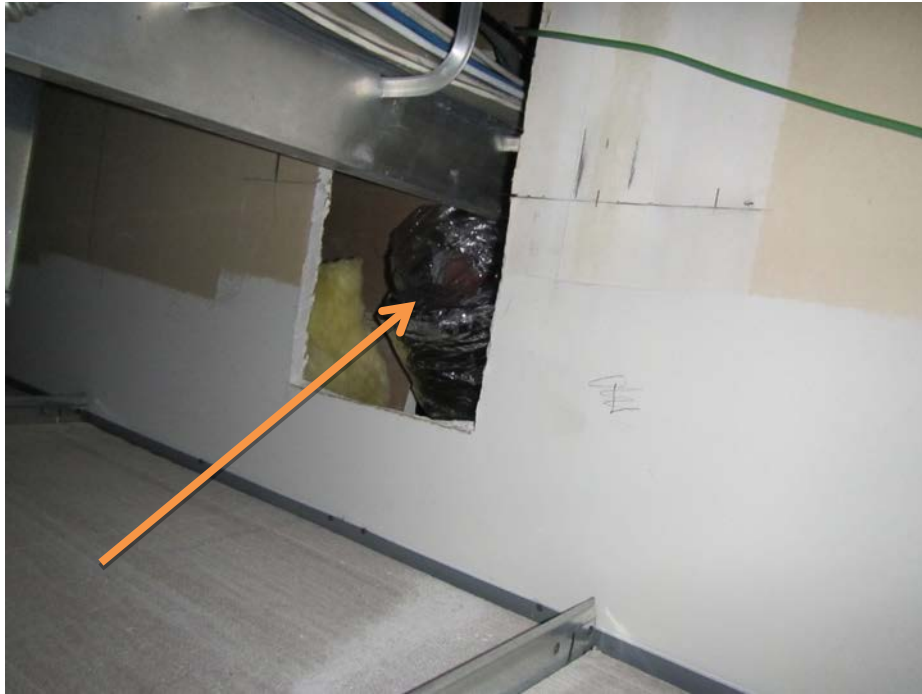
Picture 3

Portable AC exhaust hose terminates in wall cavity/ceiling plenum
